Energy Procedia 78 (2015) 1329 – 1334

6th International Building Physics Conference, IBPC 2015

Relationship between Environmental Conditions and Algal Growth on the Exterior Walls of the Ninna-ji Temple, Kyoto

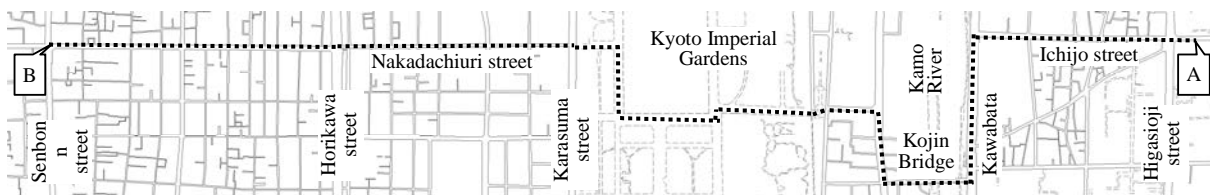
Fig. 1. Survey area.

The survey in Kyoto City was conducted to identify on which parts of the building walls the algae grow and which environmental factors affect algal growth. To study the effects of the local environment, a route passing through water areas (river and pond), green areas and urban areas was chosen. The surveyed area is along the east-west corridor of Ichijo street and Nakadachiuri street running from Kyoto University on the east to Senbon street on the west (Fig. 1). Surveys were conducted in October and November of 2008 and May of 2013. Photographs of exterior walls were taken with a digital camera in order to compare soiled and unsoiled areas. The surrounding environment, materials and the status of walls were documented. On the basis of a review and analysis of the photographs, the extent of soiling on the walls and causes of algal growth were estimated.

relatively wide streets running in an east-west direction. East and west walls were frequently shaded by the adjacent buildings. The status of algal soiling was documented on buildings within 50 m of water areas, those within 50 m of green areas, and those in the urban area from Senbon street to Karasuma street (Fig. 1). Based on a comparison of algal soiling on these areas, the effect of the regional environment on algal growth appears to be very slight (Fig. 2a).

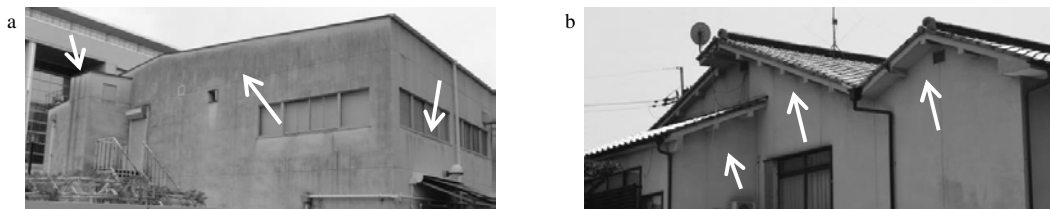
Fig. 3. (a) Walls directly exposed to rainwater; (b) walls rarely receiving rainwater.

- **(1) Wall parts directly exposed to rain (where rainwater hits, flows or is stored) (Fig. 3a).** Soiled areas extending down from the roof or the lower frame of windows was often observed. The amount of the rainwater impacting a horizontal plane or window frame was more than that on vertical planes (walls). Algae growth appeared to be concentrated along the course of running rainwater. Soiling was also observed on the lower parts of the walls near the horizontal plane (ground or horizontal eaves). Rainwater does not dry quickly, splashes against the wall and is absorbed by the existing algae. Soiling was also observed around and under clacks, where rainwater can be absorbed and stored there.

- **(2) Wall parts that rarely receive rainwater (Fig 3b).** In these areas, soiling was observed under eaves that were not exposed to rain and where the water flow was not apparent. In some cases, an entire wall was discoloured. The source of moisture for algal growth in these areas appeared to be water vapour in the atmosphere or moisture absorbed by the wall.
